SERVICE BULLETIN

Bulletin No. 75-29
Date August 22, 1975
Page 1 of 2

SUBJECT: SPARK PLUG CAP
Affected Models: GT380M and GT550M
Effective Engine No.: E NO. GT380-36035, GT550-60143
Reference: _____

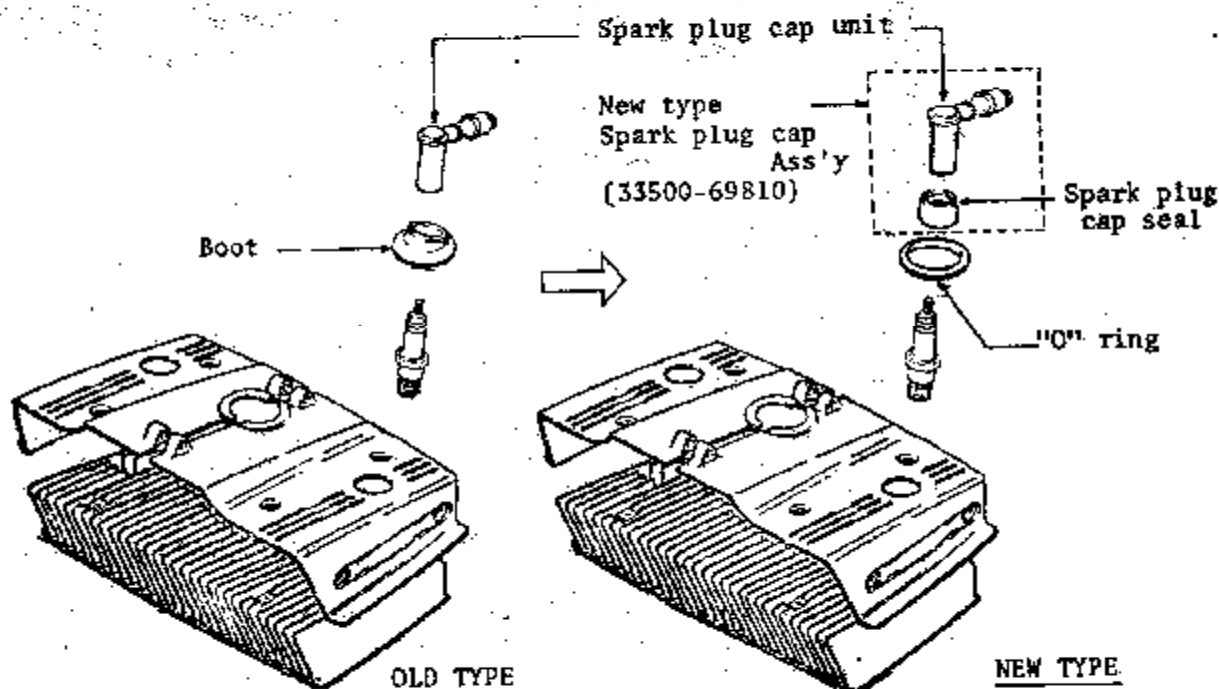
This bulletin is intended to inform you that the spark plug cap sealing has been modified into a conventional type in order to prevent a high tension leak from the spark plug cap.

In this modification, the spark plug boot has been removed and an "O" ring has been fixed to the cylinder head cover. No modification has been carried out in the cap unit itself.

Caution: In case of any engine trouble due to leakage of electricity from the spark plug cap (mis-firing of the engine), the plug cap should be changed to the new type and at the same time an "O" ring should be fixed to the cylinder head cover.

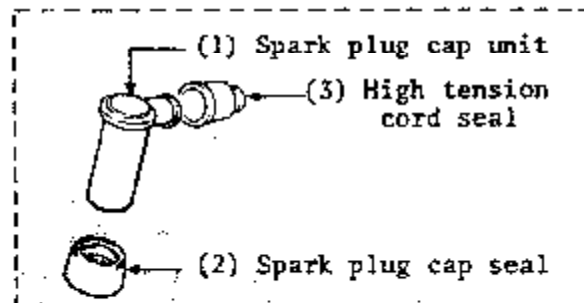
Spark plug cap Ass'y
(33500-69810)

- (1) Spark plug cap unit (33510-22010)
- (2) Spark plug cap seal (33541-69010)
- (3) High tension cord seal (33542-98000)
