SUZUKI

Service Bulletin

Subject: RM100/125 LEFT CRANKSHAFT MAIN
BEARING

Bulletin No: RM-27
Date: July 2, 1976
Read and Initial
Manager _____
Parts _____
Service MP

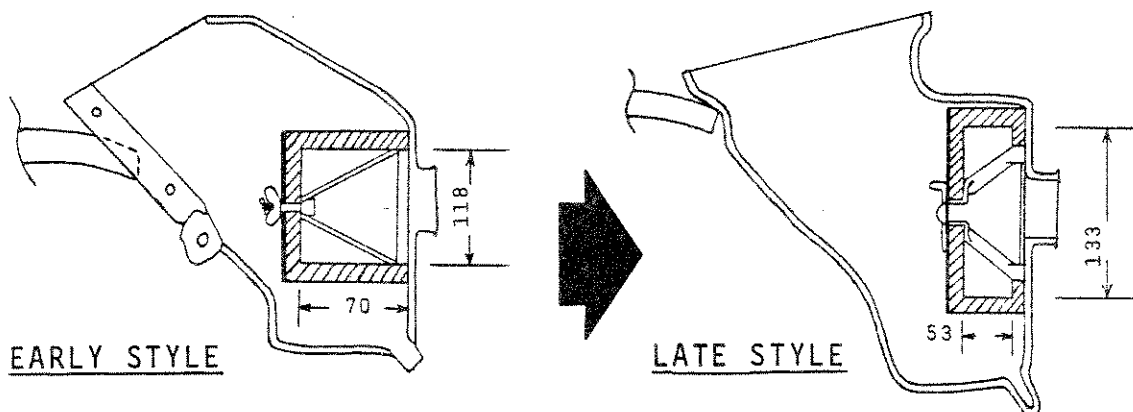
1. The shape of the air cleaner element has been changed to provide a more positive seal.
2. The shape of the air box has been changed to provide easier accessibility to the element.

3. To provide easier installation and removal of the filter element, the fastening device has been changed from a wing nut to a snap pin.
4. The carburetor air inlet hose mounting surface dimensions have been changed for more positive sealing, however, it's overall length remains the same.

1. Due to the differences in dimensions the new and old air cleaner components are not interchangeable, with the exception that the new style fender may be used with an old style air cleaner assembly.
2. When installing a new style air cleaner assembly on a unit equipped with an old style rear fender, the rear fender must be cut as shown below.

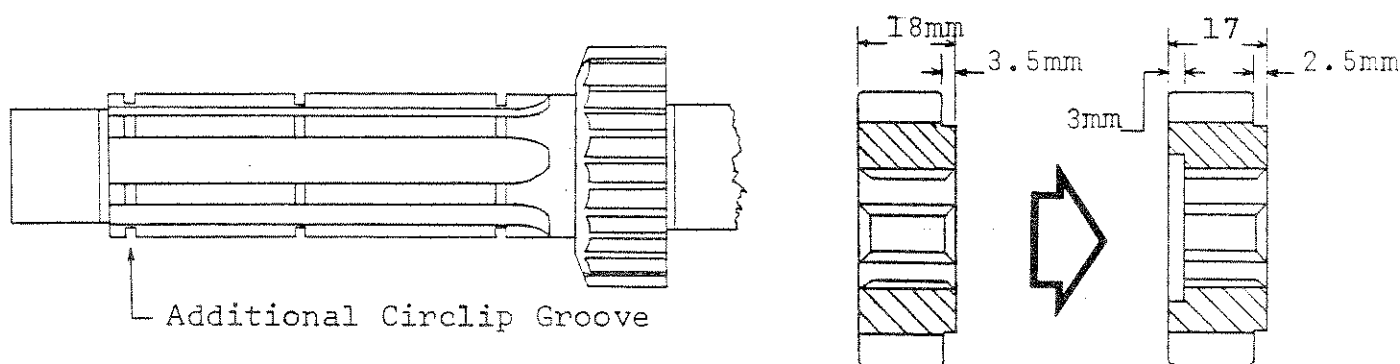
The countershaft and second drive gear have been modified in the manner illustrated below.

When installing circlip on end of shaft all other components must be slide towards 1st gear. Then, position all circlips correctly and reslide everything back towards 2nd drive gear.

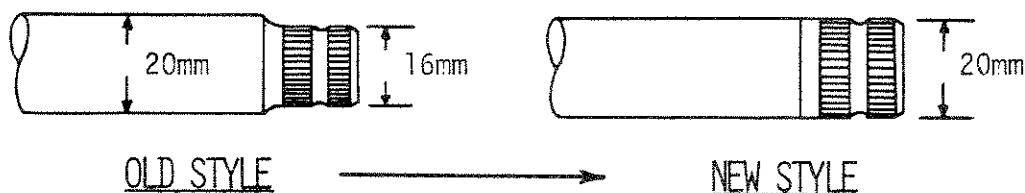
We have received reports of RM250/370 kick starter shafts breaking. To prevent this from happening, the splined end of the kick starter shaft has been increased in size as illustrated below.

Along with the kick starter shaft modification, the kick starter lever has also been modified to accommodate the increased dimensions of the new shaft.

*The new style kick starter shaft can be interchanged with the old style kick starter shaft only if the new kick starter lever is used and vice versa.

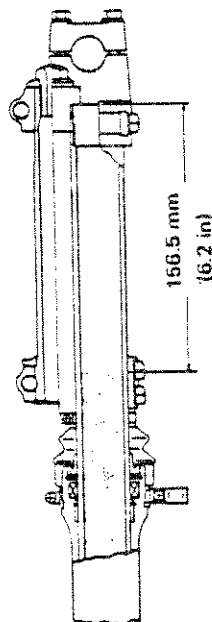
Correct Method

The oil level is then measured from the fork cap seating surface to the actual fluid level. This measurement should be:

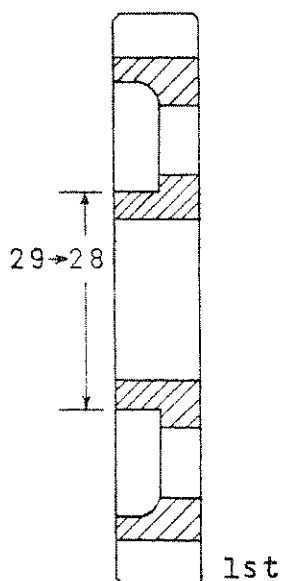
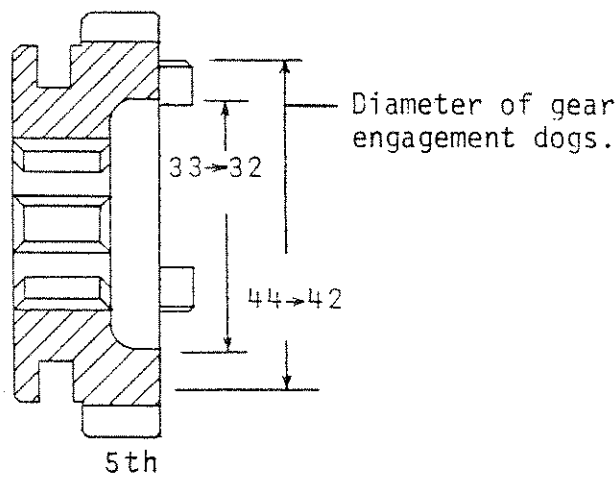
1st and 5th driven gears of the RM250 transmission have been changed to provide added strength and reliability. Although the actual gears ratios remain the same, certain structural dimensions have been changed as illustrated below.

*First and fifth driven gears are interchangeable, but only as a set.

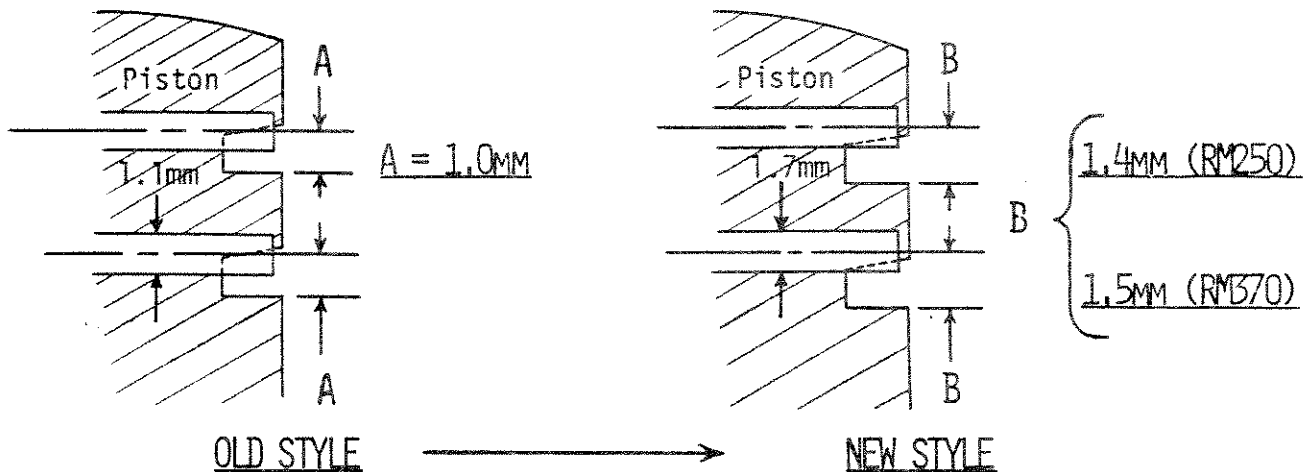
I. To increase their durability, the RM250A and RM370's piston ring locating pins have been changed as indicated below:

- The piston rings' locating pins have been increased in diameter 0.6mm, from 1.1 to 1.7mm.
- At the same time, the locating pin position has been raised 0.4/0.5mm (RM250A/370) further from the bottom of the ring groove.

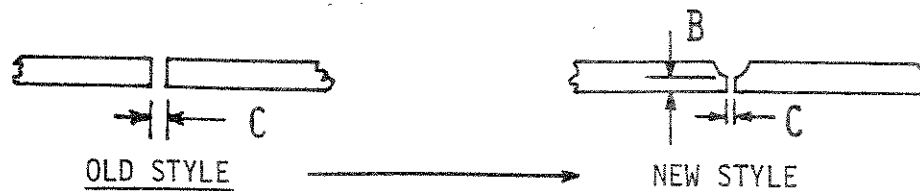
PISTON RING END SIDE VIEW

II. To accomodate the piston ring locating pin changes, the piston ring ends have been changed as illustrated below:

| MODEL | DIMENSION B NEW STYLE | NEW DIMENSION C (RING END GAP) | |
| RM250A | 0.4 mm | 1.4-1.7mm | 0.2-0.4mm |
| RM370 | 0.5 mm | 0.2-0.4mm | 0.2-0.4mm |

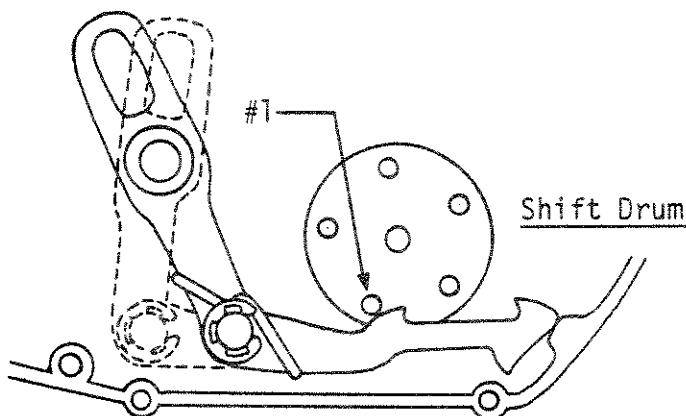
We have had reports of RM80's gear shift lever sticking in the up position, when shifting into higher gears; 3rd, 4th, or 5th. When this happens, the shift drum of the transmission is actually rotating past the normal stopping point, which allows the next shift drum pin (#1 in illustration) in rotation to restrict the shifting pawl's movement back to its original position.

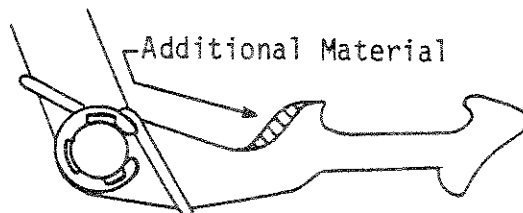
This situation has been cured by the addition of a small amount of material applied to the gear shift pawl, which restricts the shift drum from rotating too far.
